**DESERET POWER**  
ELECTRIC COOPERATIVE

**BONANZA POWER PLANT  
ANNUAL PROFESSIONAL ENGINEER  
CCR UNITS INSPECTION**

**January 2022**

**Qualified Professional Engineer Certificate**

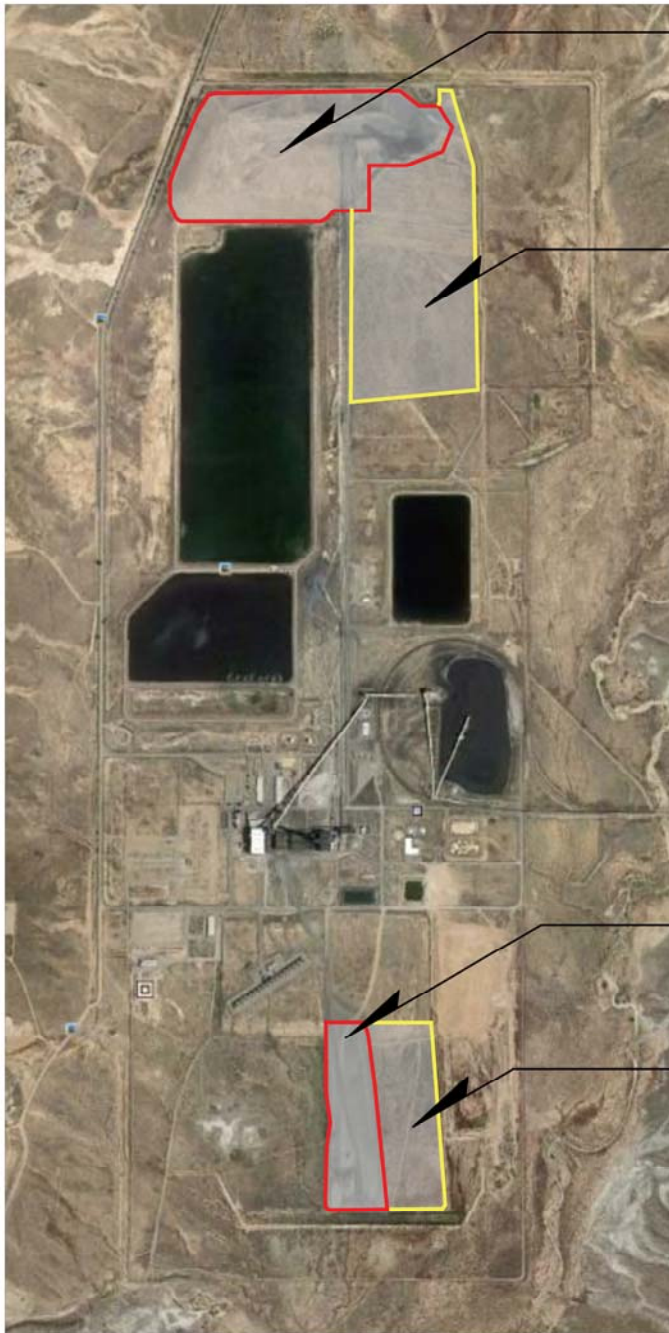
**FLY ASH AND FGD SLUDGE LANDFILL**  
**TOTAL ±148 ACRES**

**EXISTING LANDFILL (FULL)**  
**FLY ASH AND FGD SLUDGE LANDFILL**  
**±72 ACRES**

**EXISTING LANDFILL (NOT FULL\*)**  
**FLY ASH AND FGD SLUDGE LANDFILL**  
**±76 ACRES**

One of the existing landfills is located to the north end of the Bonanza site and mainly contains fly ash and flue gas desulfurization (FGD) material. This CCR unit will be referred to as the Fly Ash and FGD Sludge Landfill. The other existing landfill is located to the south end of the Bonanza site and mainly contains bottom ash and boiler slag. This CCR unit will be referred to as the Bottom Ash Landfill. Refer to Appendix A, Site Maps.
